March 19th, 2026

Fairfax Building C Condominium Association,
7354 Fairfax Dr,
Tamarac, FL 33321

Re: Expansion Joint Replacement & Cause of Cracks & Tile Delamination on Walkways

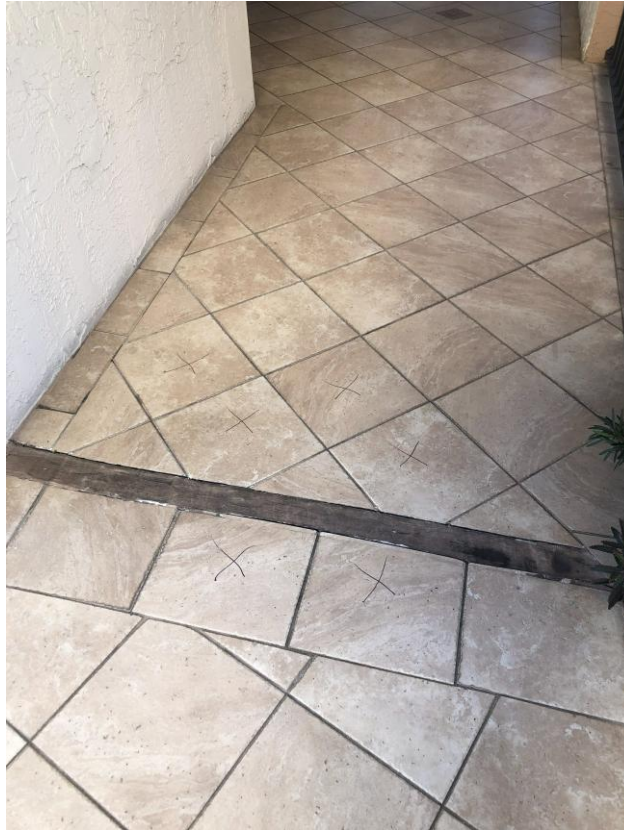
- The existing expansion joint sealant (caulking) was observed to be deteriorated, exhibiting signs of aging, loss of elasticity, and potential separation from the joint interfaces.

Photo 1: Deteriorated sealant was observed on the expansion joint

- Remove and properly dispose expansion joint sealant and filler materials from all existing expansion joints.
- Remove a minimum of three (3) feet of existing tile on both sides of each expansion joint to allow adequate access for repair and proper installation of new materials.

- Install new expansion joint filler and sealant materials in accordance with manufacturer recommendations and applicable industry standards.
- Install a suitable expansion joint cover system (cover plate) over the joint to offer additional protection against water intrusion and mechanical wear.

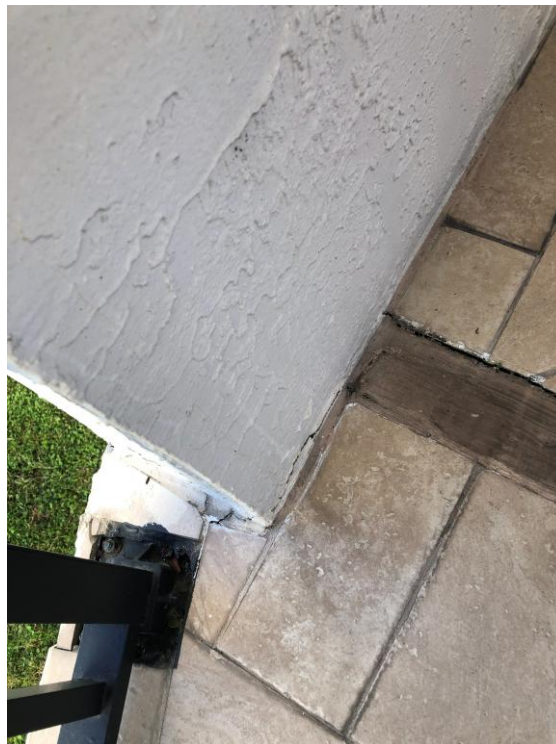
Photo 2: Deteriorated sealant observed on expansion joints

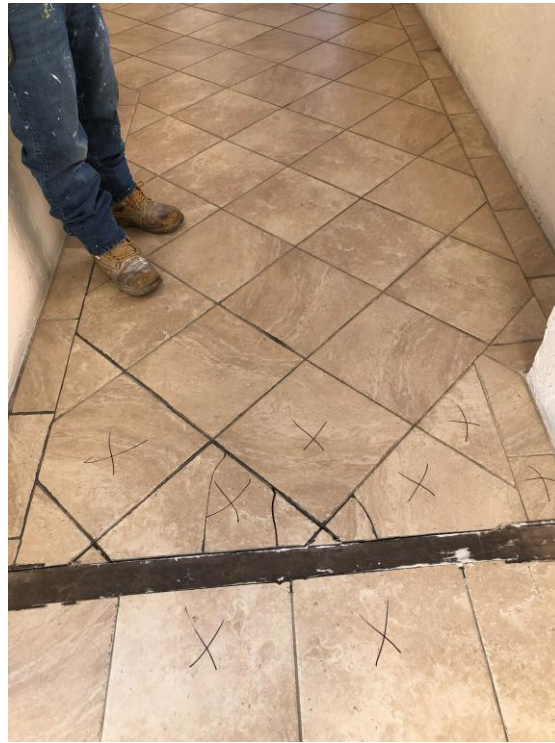
- Cracked and delaminated tiles were observed in areas immediately adjacent to the expansion joints. The extent and pattern of distress are consistent with localized loss of bond within the tile assembly.

- Based on visual observations, the deteriorated condition of the expansion joint materials likely permitted water intrusion into the tile assembly. The presence of moisture beneath the tiles may have adversely affected the bond of the thin-set mortar, contributing to tile delamination and cracking.

Photo 3: Cracked and delaminated tiles next to the expansion joint

- Install a high-quality, exterior-grade thin-set mortar specifically designed for use in areas subject to movement, including those adjacent to expansion joints.

- Install new tiles in the removed areas, ensuring proper alignment, bonding, and compatibility with the surrounding existing finishes.
- Thoroughly clean and prepare the expansion joint openings in strict accordance with the manufacturer's specifications to ensure proper adhesion and performance of the new joint system.

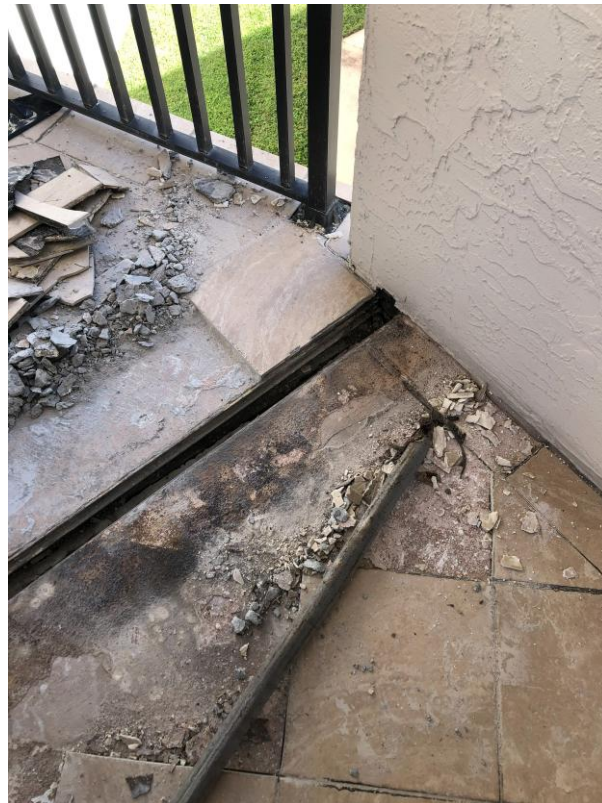
- Selective removal of tiles within the areas of concern was performed to evaluate the condition of the underlying substrate. The exposed concrete slab was found to be generally sound, with no visible signs of structural distress or material deterioration.

Photo: Existing condition of concrete slab after removal of tiles

- Scarify the exposed concrete slab surface in accordance with industry standards to achieve an appropriate bond profile, followed by the installation of an appropriate waterproofing system compatible with the proposed tile assembly.

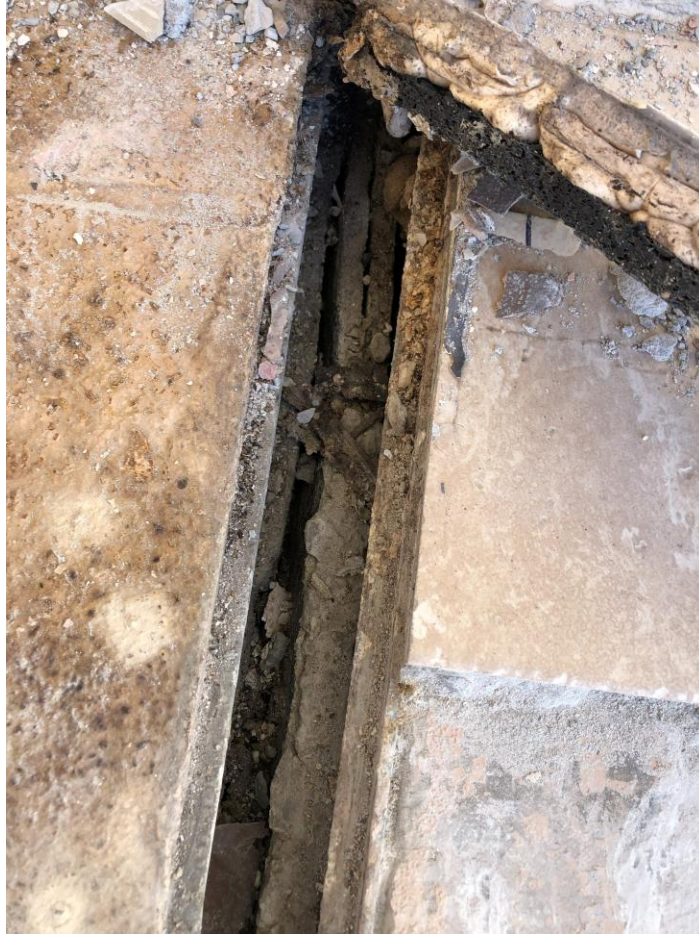
- The expansion joint filler material was observed to be loose, cracked, and deteriorated. The material lacked integrity and could be removed with minimal effort, indicating a loss of functionality of the joint system.

Photo 5: Existing condition of expansion joint after removal of sealant and expansion joint material
